## FATIGUE TESTS OF PLATES AND BEAMS WITH STUD SHEAR CONNECTORS

By  
K. A. SELBY  
J. E. STALLMEYER  
and  
W. H. MUNSE

A Report of an Investigation Conducted  
by  
THE CIVIL ENGINEERING DEPARTMENT  
UNIVERSITY OF ILLINOIS  
In Cooperation With  
GREGORY INDUSTRIES, INC.

UNIVERSITY OF ILLINOIS  
URBANA, ILLINOIS  
JULY 1963

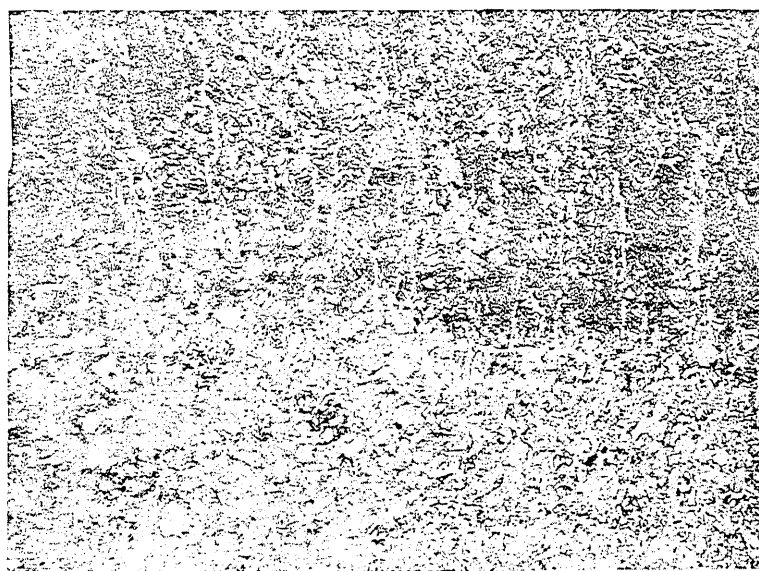
FIG. 20 MACROGRAPHS AND MICROGRAPHS OF SPECIMEN GIAZ

Macrograph 3x

Macrograph 6x

Detailed macrographs and micrographs of a variety of specimens are contained in Figs. 20 through 24. Hardness surveys from the base plate material across the heat-affected zone and weld metal to the base material of the stud are contained in Figs. 25 through 28. The specific microstructures vary somewhat in width of the heat-affected zone and weld metal zones. The relative amount of martensite in the heat-affected and weld metal zones, and the fineness of the columnar structure of the weld metal, vary as a result of the difference in the heat input to the various specimens. The amount of weld metal increases with the amount of heat input to the specimens, as does the width of the heat-affected zone. Consequently, GIA2 and GIC5 have the narrowest weld metal and heat-affected zones, followed by GIB1 and GIB16, and the fineness of the weld metal structure decreases in the same order. Specimen GIB16 has a higher percentage of martensite in the heat-affected zone than GIB1.

Typical failure of all specimens is evidenced in GIA2. Both of the macrographs in Fig. 20 show a fatigue crack on the right hand edge of the stud which initiated at the fusion line and traversed the heat-affected zone. This crack is not the crack which resulted in final failure of the specimen but is rather 180 degrees away from the source of ultimate failure. Propagation of the crack is transgranular as seen in GIA2.
